WASTEWATER DIVISION

Subject: HILO WWTP SEWER SPILL
In-plant Sewage Spill, Hilo, Hawai'i
April 15, 2020: 10:45 AM

HILO WWTP SEWER SPILL
In-plant Sewage Spill, Hilo, Hawai'i
April 15, 2020: 10:45 AM

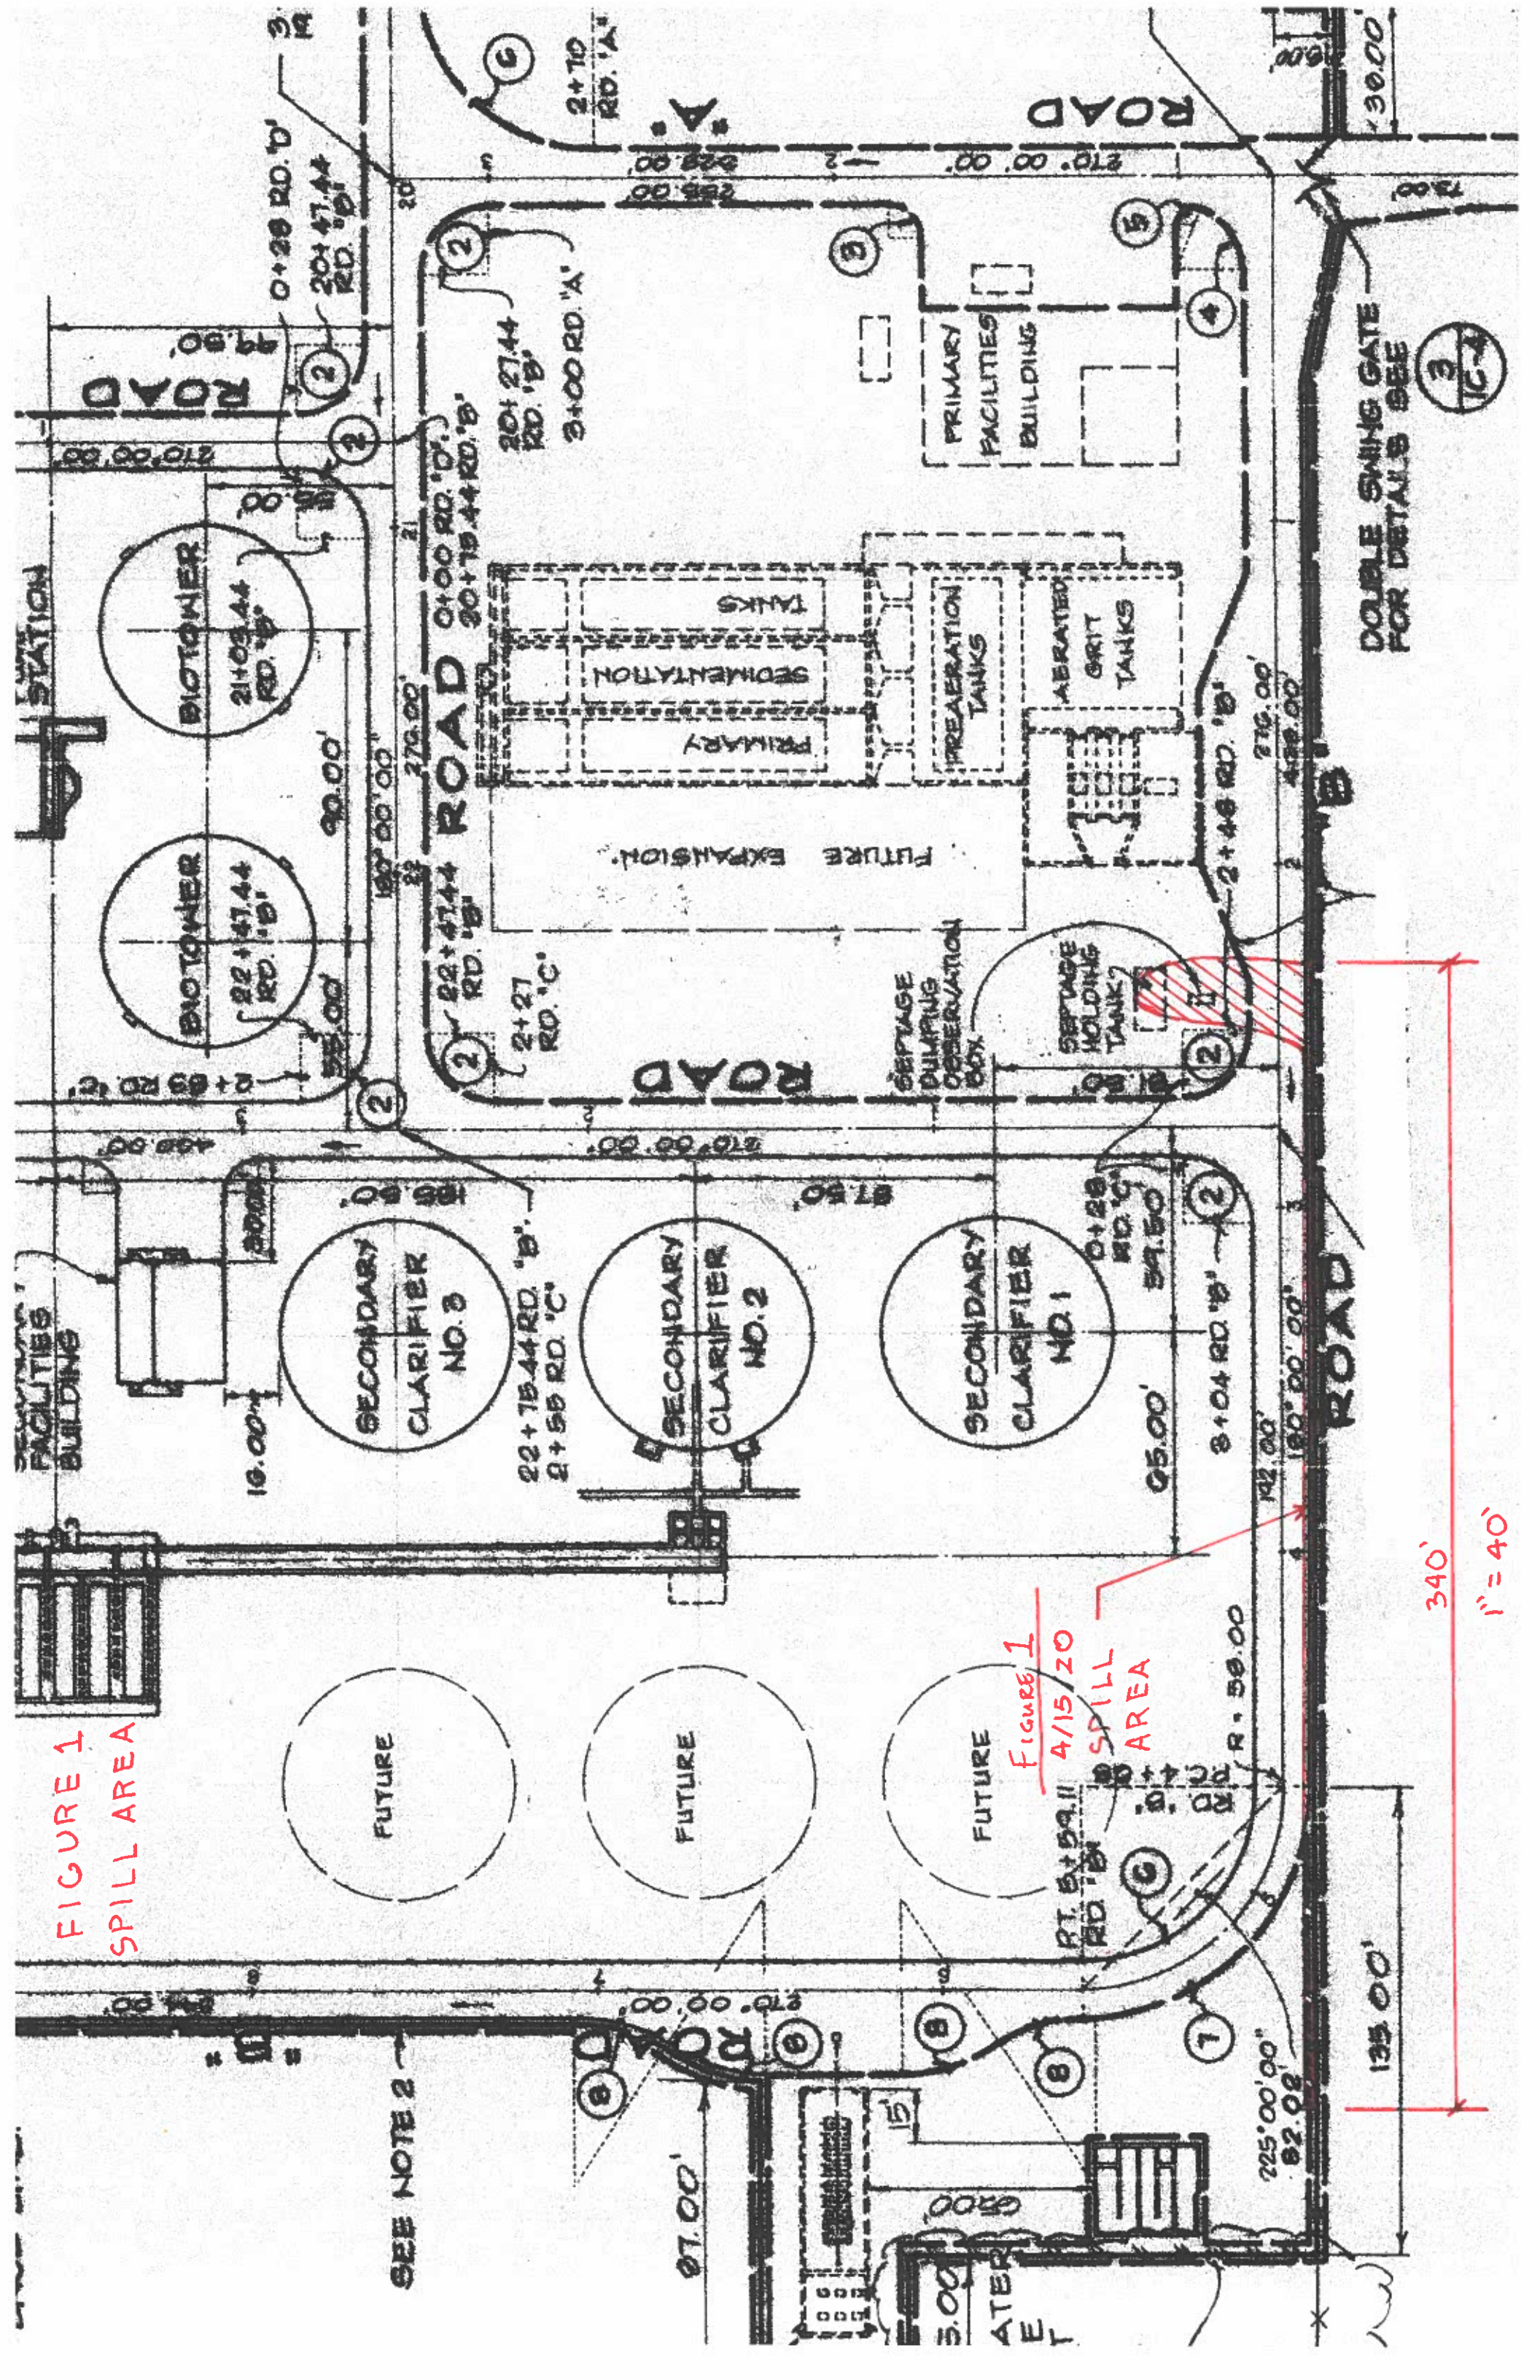
FIGURE 1
SPILL AREA

- WWTP Mechanics first noticed water flowing away from septage receiving pit and traversing along property fence-line (see attached Figure 1); No operators were present so mechanics immediately tracked down and notified operators of the spill; Additional photographs of the spill event (see attached Pictures of Spill).
- A delineation of spill area is shown on a site plan (see attached Figure 1). Based on the plotted measurements, the volume of the spill was calculated to be in the vicinity of 3,403 gallons:

Volume of water around septage receiving station plus road = 1,496 gallons (20' x 40' x 3 inch depth)

Volume of water along Fence = 1,907 gallons (340' x 3' x 3 inch depth)

- Although this represents a standing water volume (ponding), the area (downstream) by the chlorine contact building did not flood. If significantly more spill volume occurred, then this low area would have had an area of ponded water. No one observed any ponding of wastewater in that low lying area.

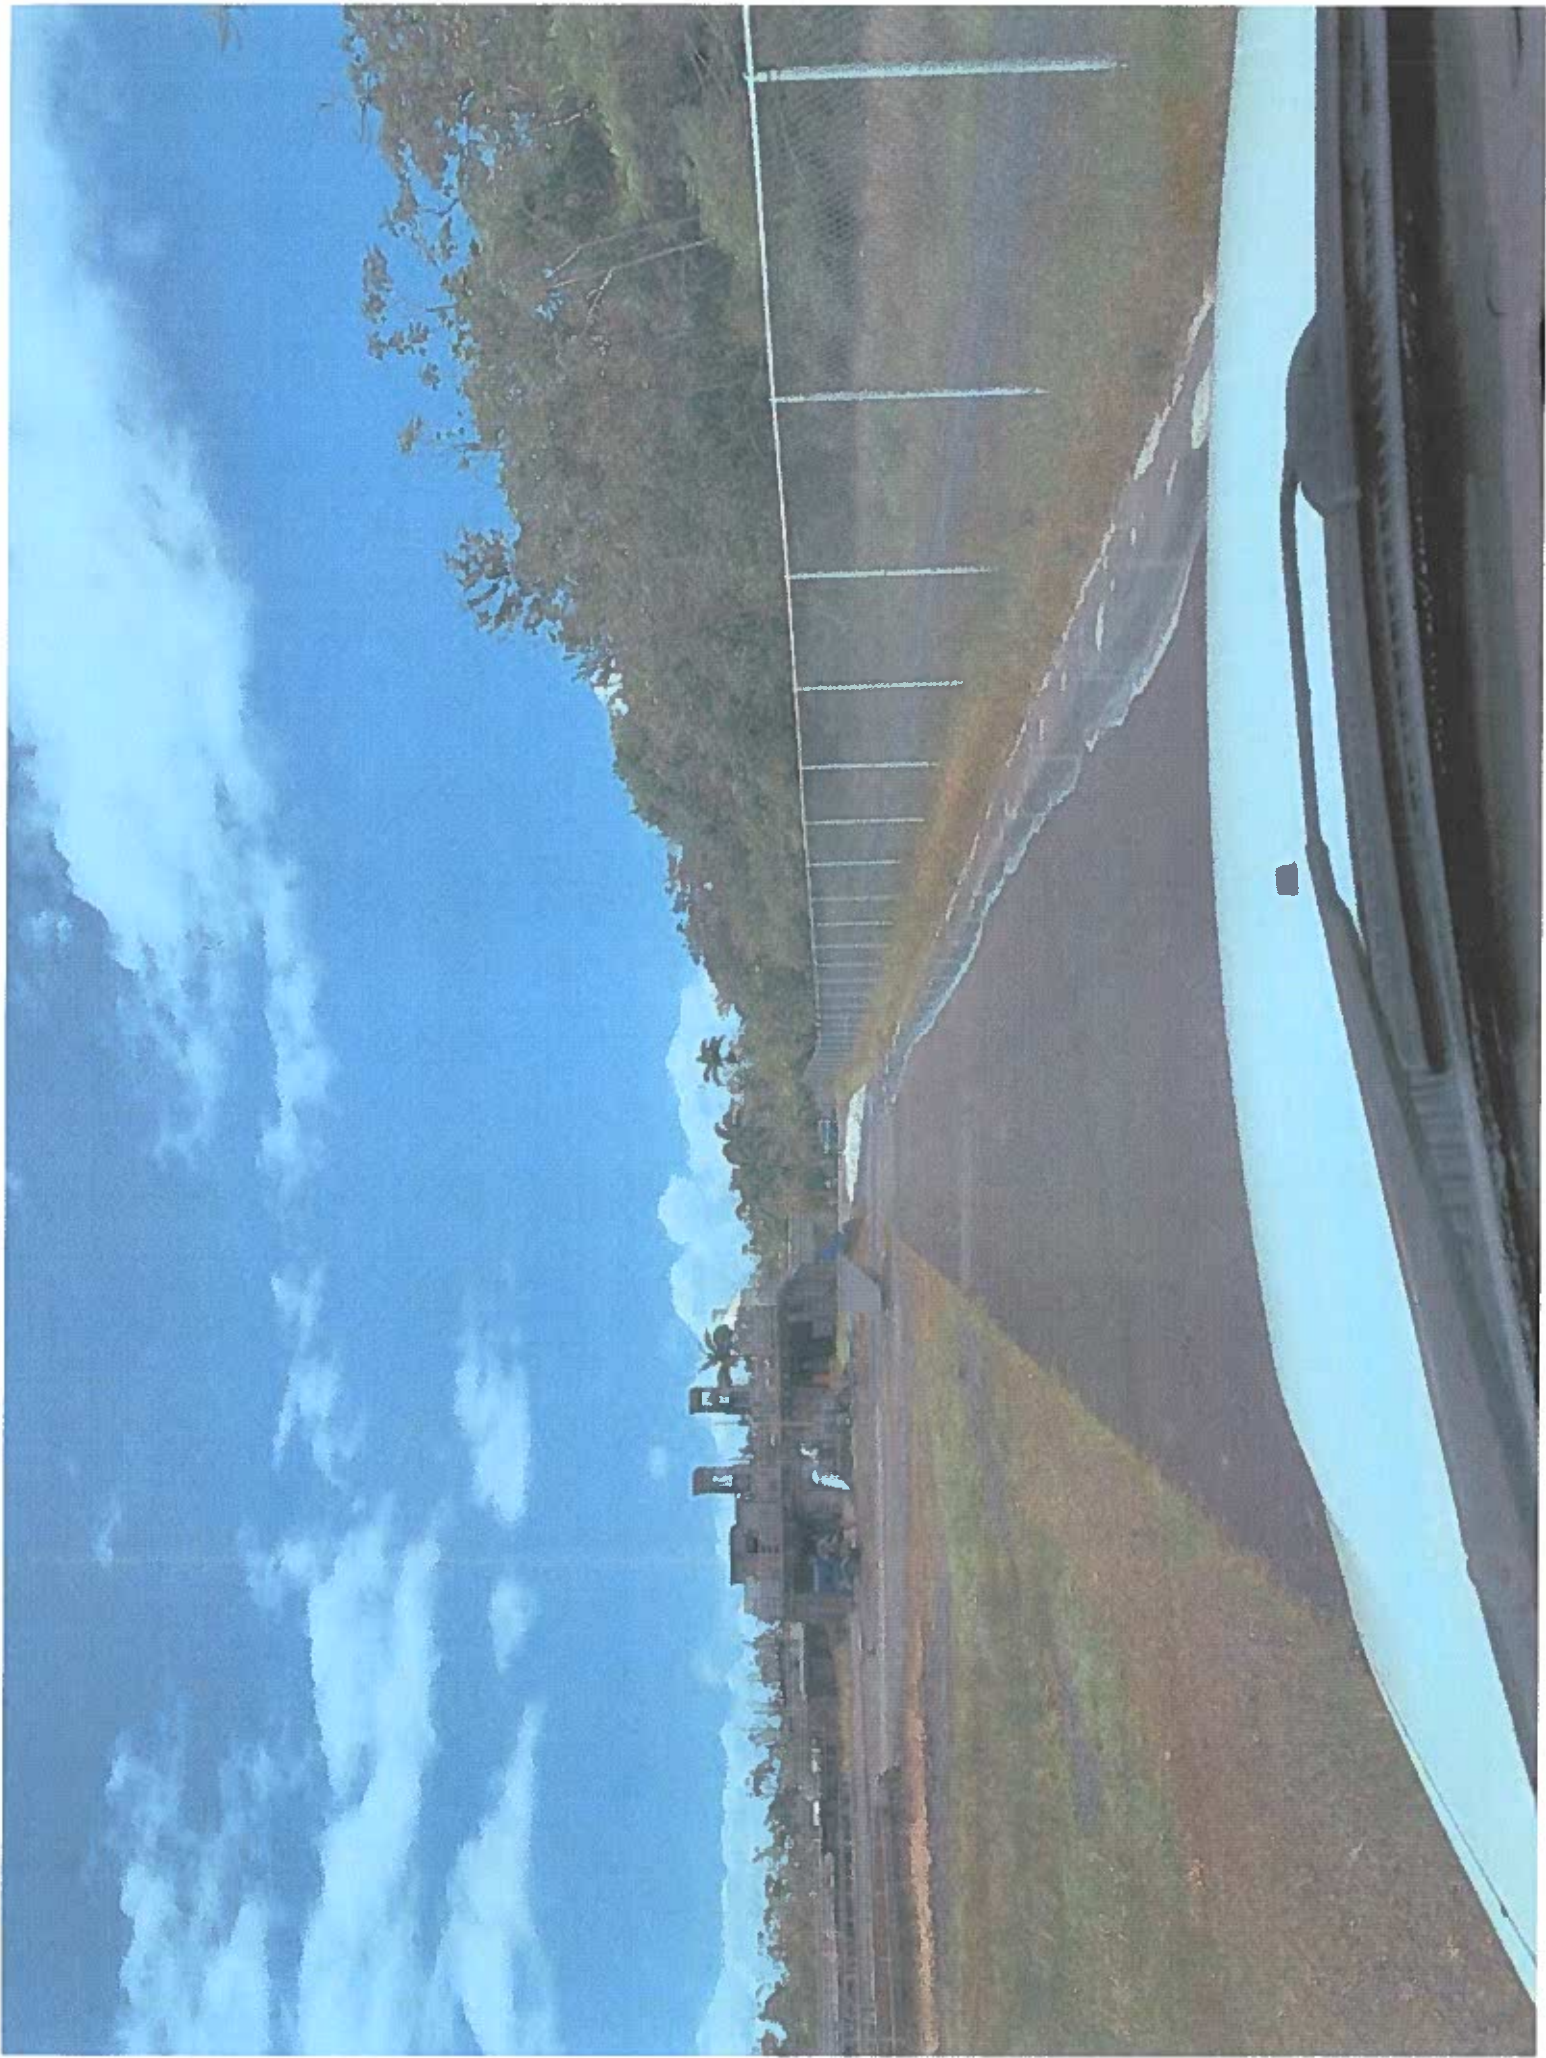
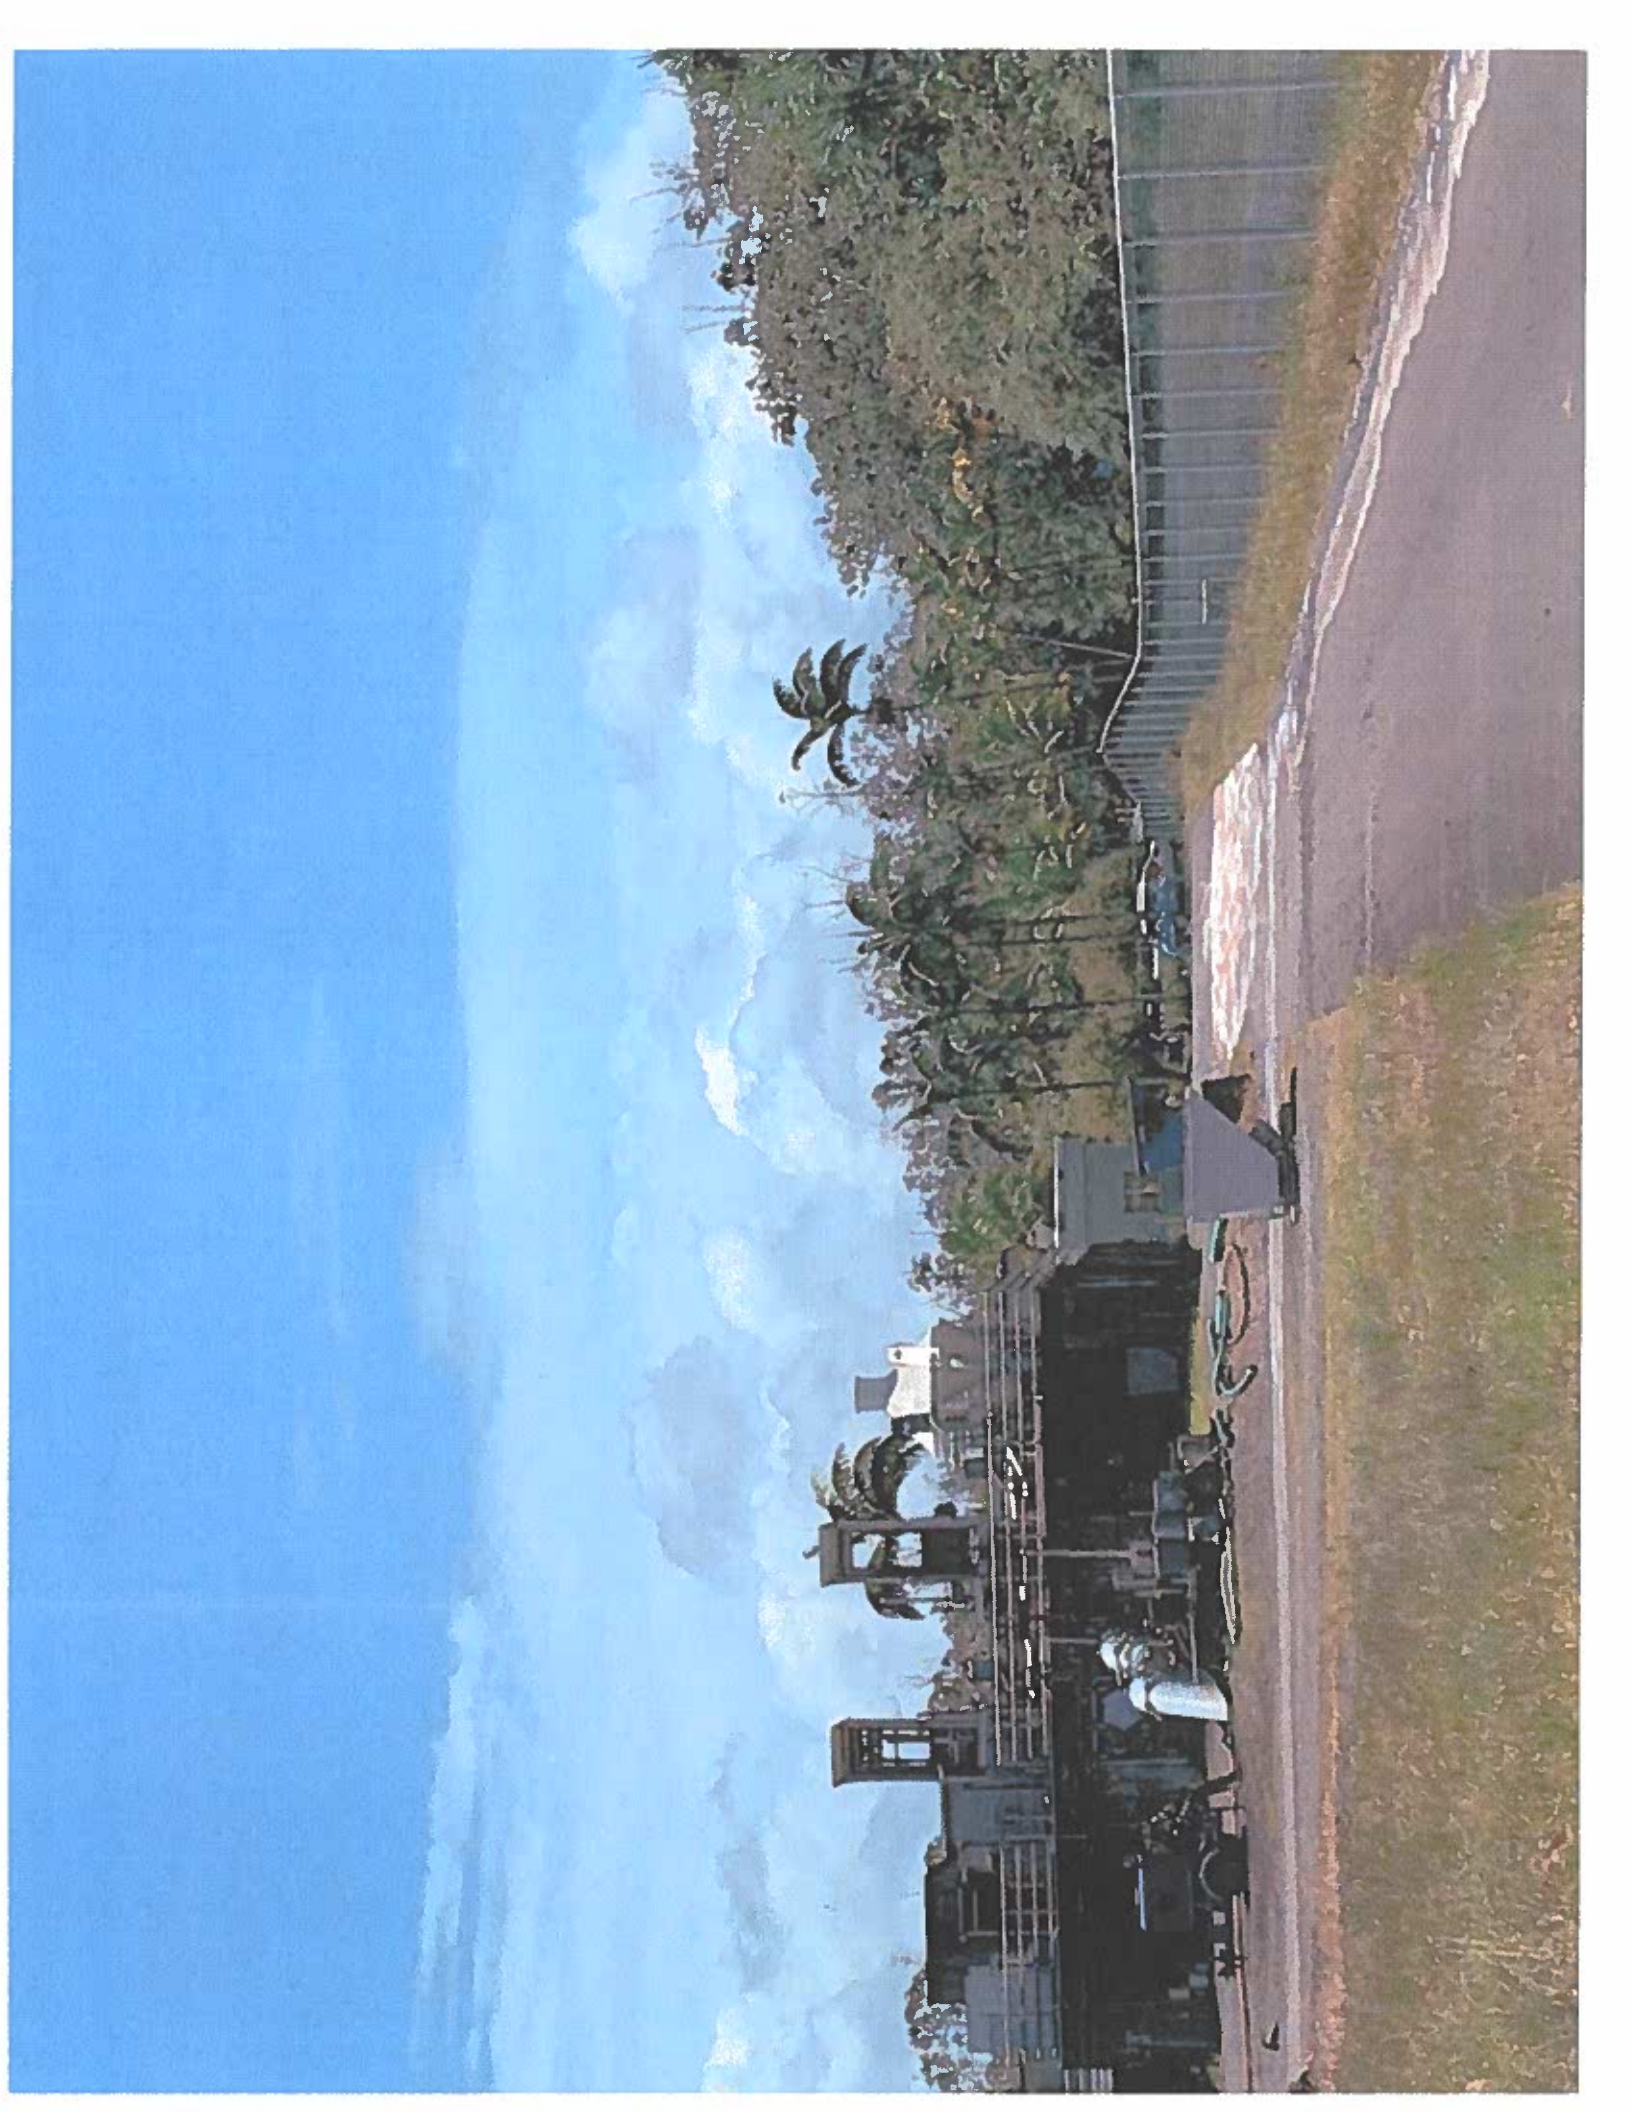
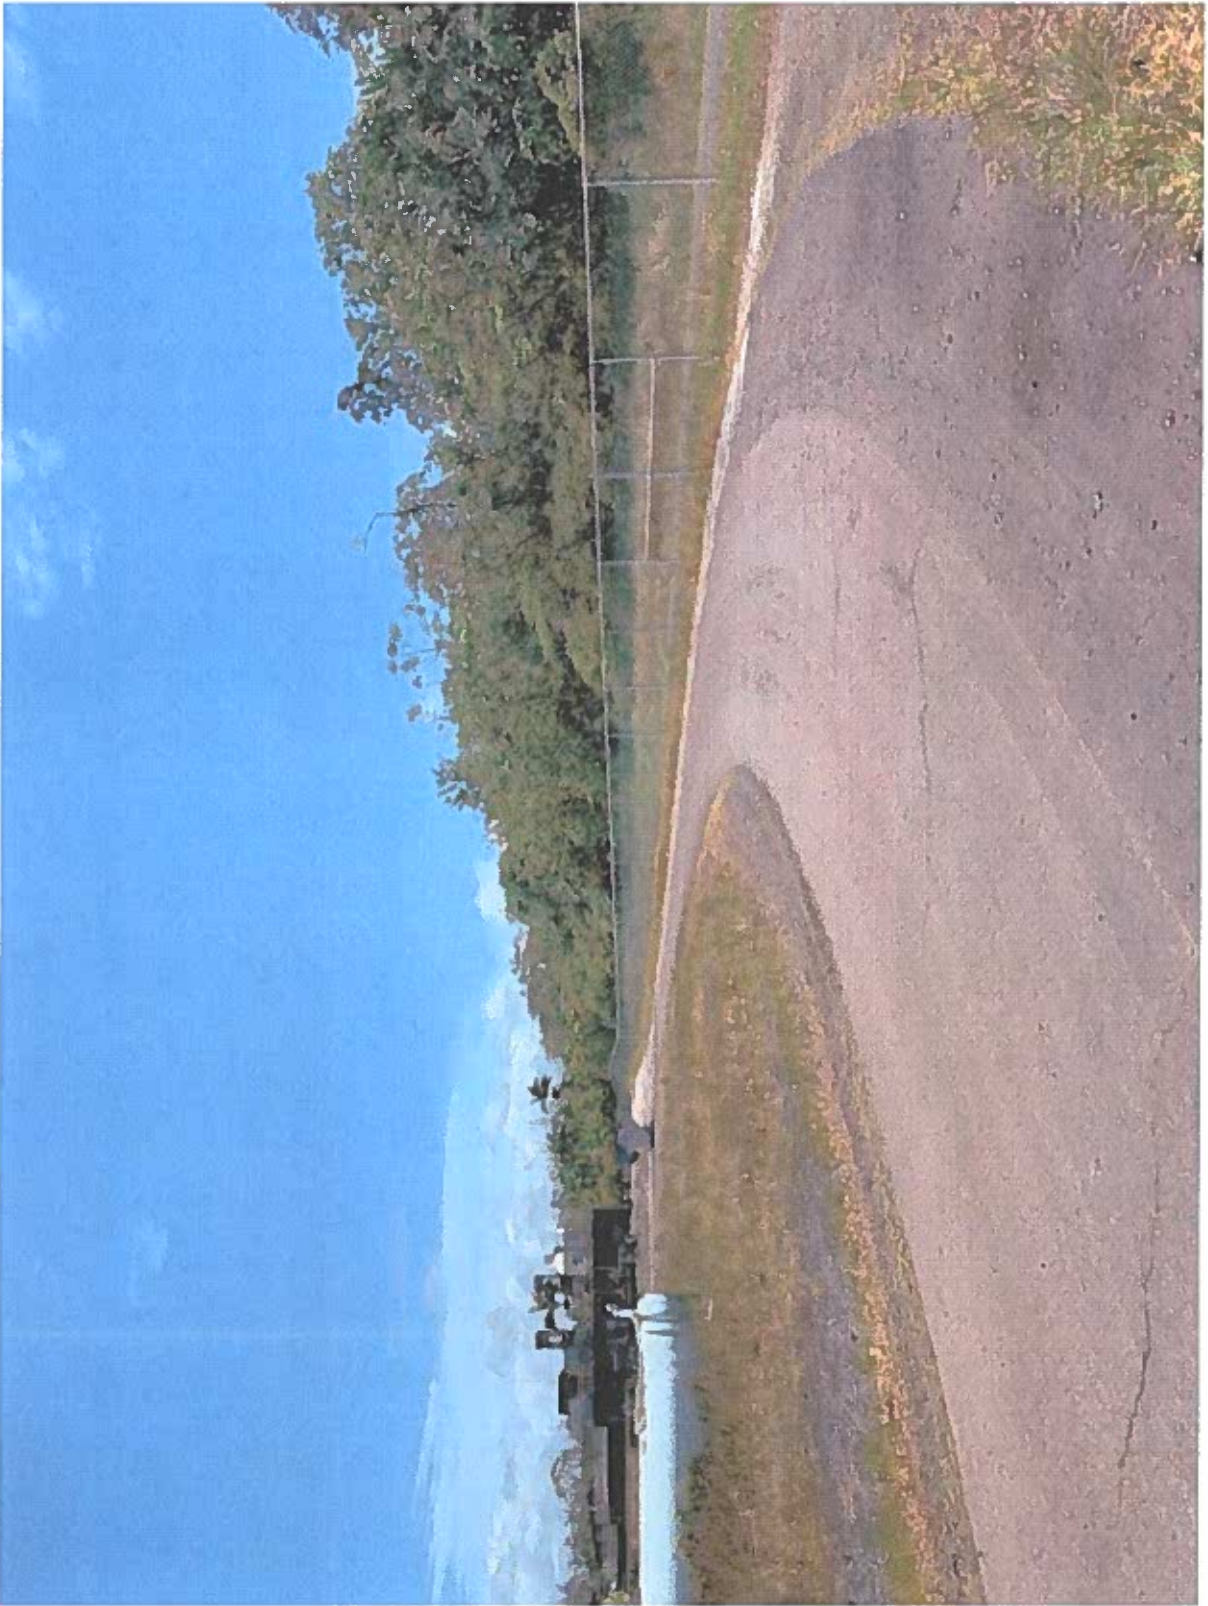
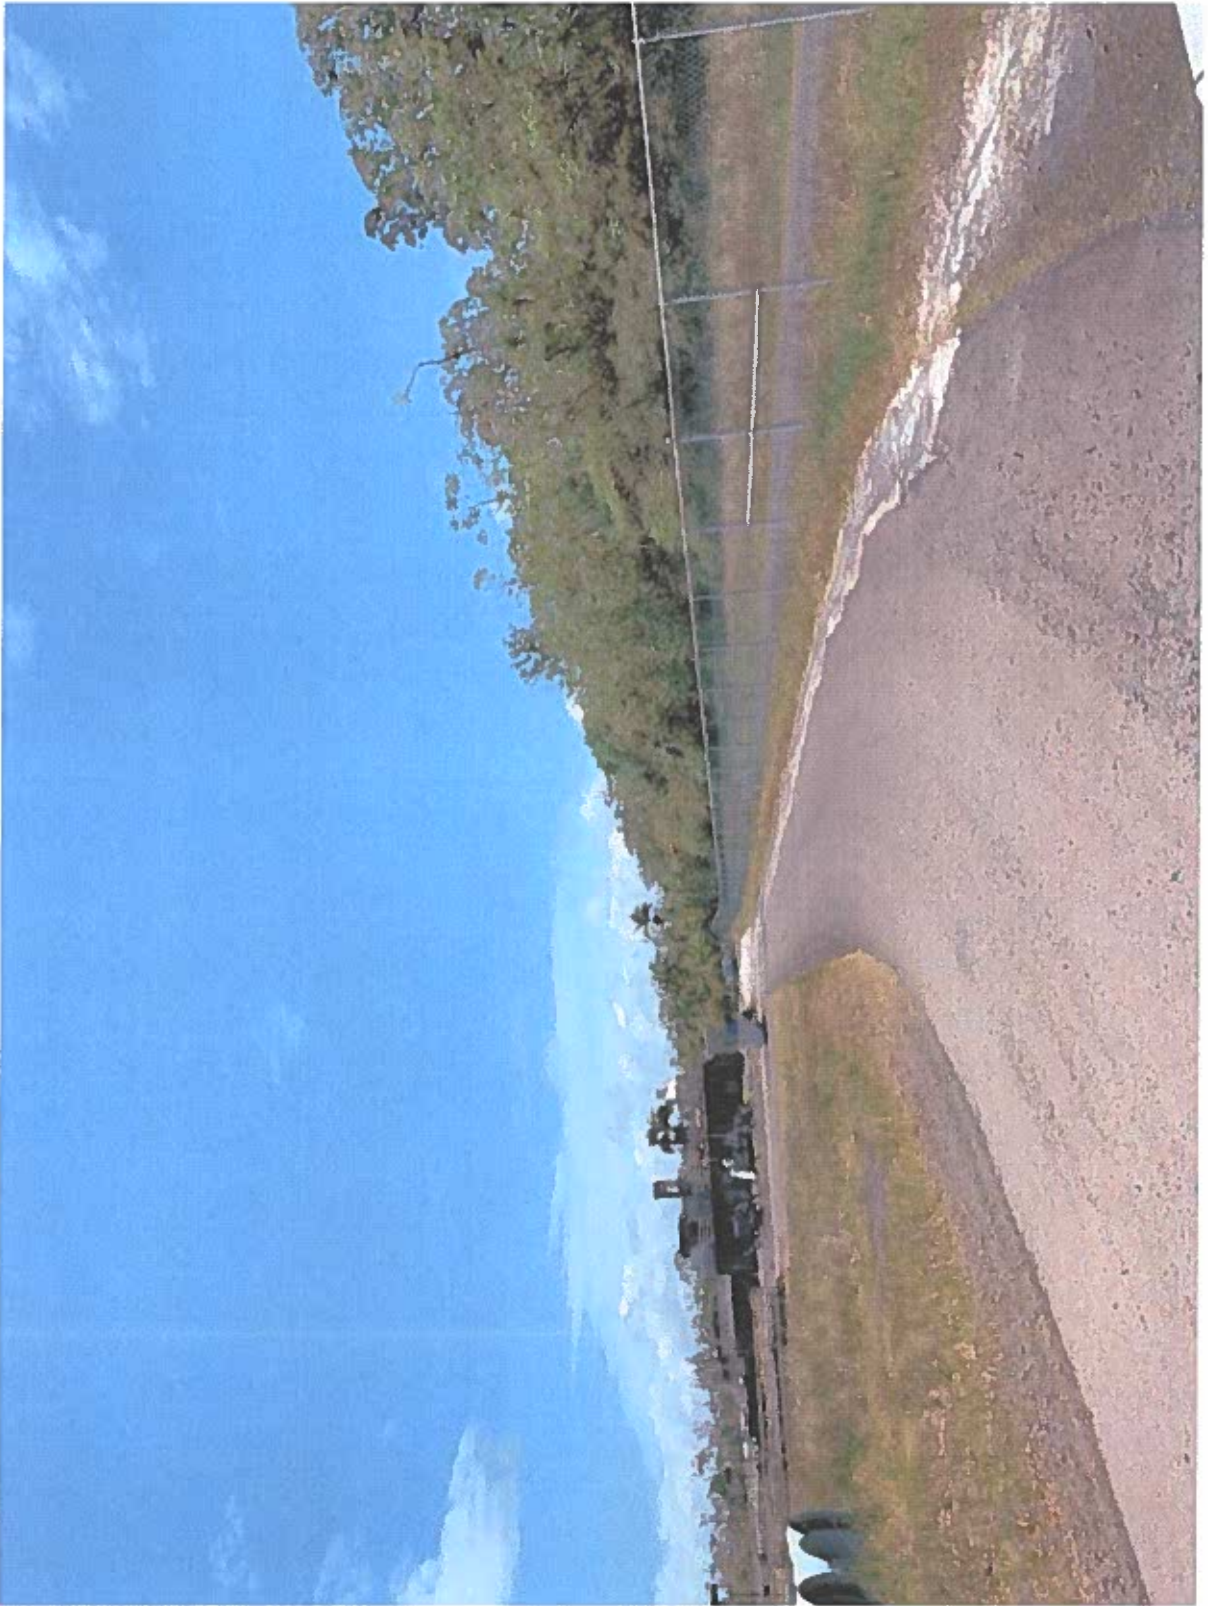
1. As indicated in the attached Wastewater Spill Report (see attached APPENDIX E), the operators at Hilo WWTP initially reported 400 gallons of secondary treated effluent from the secondary clarifier scum pit discharged to the ground because the flexible hose disconnected during pumping. Crews were flushing/cleaning the scum pit and discharging it into the septage receiving pit when the hose disconnected. After approximately 4 minutes of pumping, the operator realized that a spill to ground was occurring. Because the spill was reported as 400 gallons, the Superintendent reported the spill to the Wastewater Division (WWD) on Thursday at 4:24 PM.
2. On Friday, April 17, 2020, the WWD Deputy Chief proceeded to gather additional information of the spill event after viewing pictures and a video of the spill event. The additional information gathered included the following:

Description/Cause: Secondary Scum pit was being pumped out with portable pump. Discharge hose was placed down into septage receiving pit. During pumping, hose worked its way out of pit. And released ~400 gal of secondary scum pit water onto ground where it traveled down asphalt inside plant grounds.

1. The pump was immediately turned off when it was realized that a spill to ground was occurring.
2. The affected area was cleaned and disinfected with sodium hypochlorite.
3. The spill response team will be re-trained to determine the extent of the spill's impact area and to verify the extent of the spill (in this case, it was not verified that the spill did not migrate beyond the property fence or enter into receiving waters).

Operations was instructed to secure discharge hose by tying it down to further secure it in the future.
This spill was logged into the Non- Public >50 gal. log on our server
