DEPARTMENT OF ENVIRONMENTAL MANAGEMENT

Subject: Notice of Apparent Violation (NAV)

Wastewater Collection System Condition and Sewage Overflows

DOH Reference Number 09005EBT.20

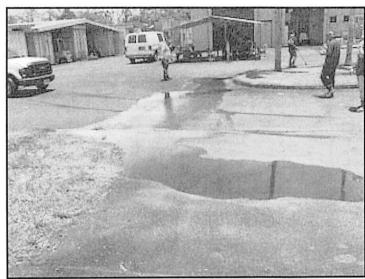
Photo 1: showing area of spill by Administration Building

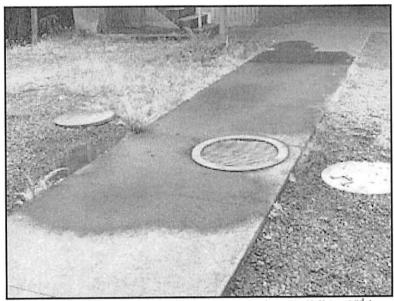
Photo 2: showing area of spill by Dewatering Building-2nd location

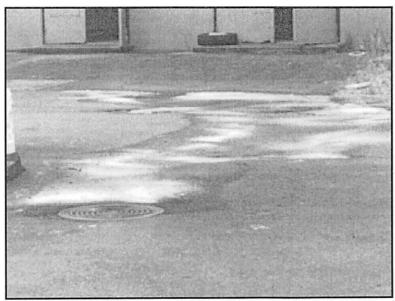
Photo 3: showing area of spill by Administration Building-Pitchlor Application
