WASTEWATER DIVISION

Subject: HILO WWTP SEWER SPILL
In-plant Sewage Spill, Hilo, Hawai'i
April 15, 2020: 10:45 AM

HILO WWTP SEWER SPILL
In-plant Sewage Spill, Hilo, Hawai'i
April 15, 2020: 10:45 AM

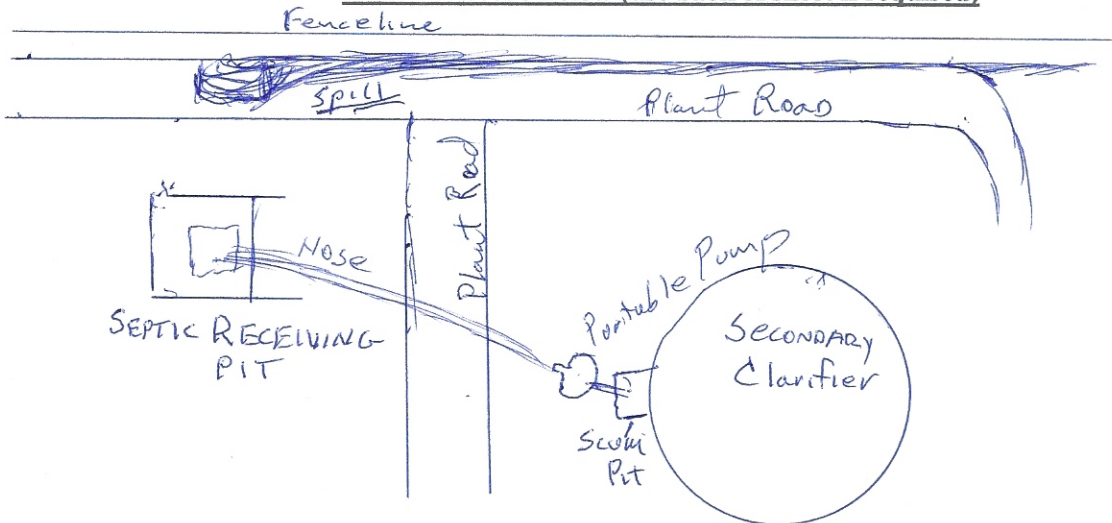
FIGURE 1
SPILL AREA

- WWTP Mechanics first noticed water flowing away from septage receiving pit and traversing along property fence-line (see attached Figure 1); No operators were present so mechanics immediately tracked down and notified operators of the spill; Additional photographs of the spill event (see attached Pictures of Spill).
- A delineation of spill area is shown on a site plan (see attached Figure 1). Based on the plotted measurements, the volume of the spill was calculated to be in the vicinity of 3,403 gallons:

Volume of water around septage receiving station plus road = 1,496 gallons (20' x 40' x 3 inch depth)

Volume of water along Fence = 1,907 gallons (340' x 3' x 3 inch depth)

Description/Cause: Secondary Scum pit was being pumped out with portable pump. Discharge hose was placed down into septage receiving pit. During pumping, hose worked its way out of pit. And released ~400 gal of secondary scum pit water onto ground where it traveled down asphalt inside plant grounds.
